Manhole Inspection Summary

Manhole # S27A__075MH

Location Address: **819 GEORGE ST**

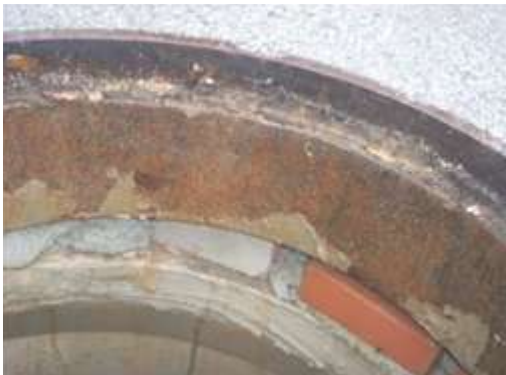
Defect 1

Condition: ☐ Sound ☐ Cracked ☐ Root Intrusion ☐ Loose Brick ☒ **Deteriorated**

DETERIORATED CHIMNEY

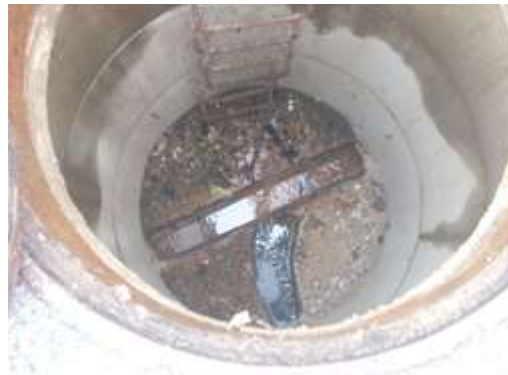
Defect 2

Count: **9** Missing: **0** ☒ **Corroded**

CORRODED STEPS

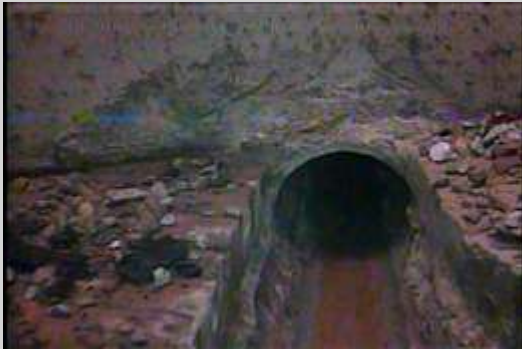
12 O'Clock Outflow

8 in. Circular Gravity Sewer
Pipe Out @ 12 O'Clock

Pipe Height: **8.4** (in.) Rod and Bar (Angled)
Pipe Material: **Clay** ☐ Pipe Lined
Invert Depth: **10.90** (ft.) Flow Characteristics: **Slow**
Deposits: ☒ None ☐ Mud ☐ Sludge ☐ Debris ☐ Grease
Silt Depth: (in.) Deposits Extent:
Infiltration: **None** Pipe Seal Cond: **Sound**

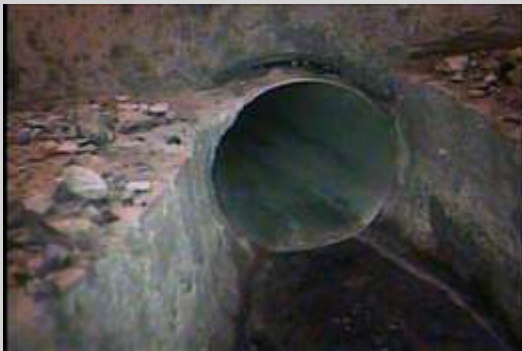
3 O'Clock Inflow

8 in. Circular Gravity Sewer
Pipe In @ 3 O'Clock

Pipe Height: **7.2** (in.) Rod and Bar (Angled)
Pipe Material: **PVC** ☐ Pipe Lined
Invert Depth: **10.76** (ft.) Flow Characteristics: **Slow**
Deposits: ☒ None ☐ Mud ☐ Sludge ☐ Debris ☐ Grease
Silt Depth: (in.) Deposits Extent:
Infiltration: **None** Pipe Seal Cond: **Sound**

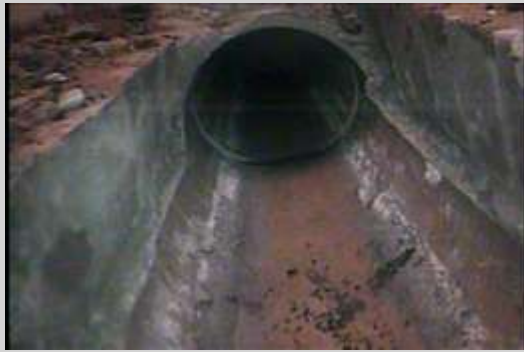
6 O'Clock Inflow

8 in. Circular Gravity Sewer
Pipe In @ 6 O'Clock

Pipe Height: **8.4** (in.) Rod and Bar (Angled)

Pipe Material: **Clay** ☐ Pipe Lined

Infiltration: **None**

Pipe Seal Cond: **Sound**
